# BEYOND MISINFORMATION

What Science Says About the Destruction of  
World Trade Center Buildings 1, 2, and 7

ARCHITECTS  
& ENGINEERS  
*for 9/11 TRUTH*

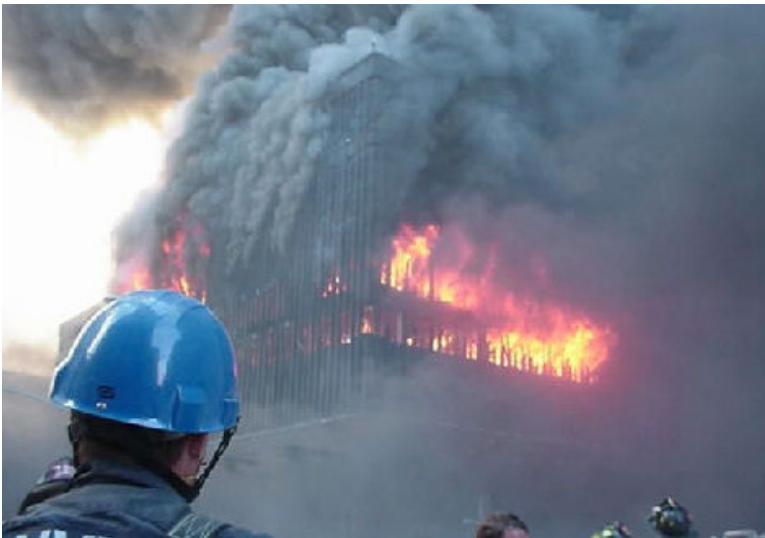
WTC 5 on September 11, 2001.

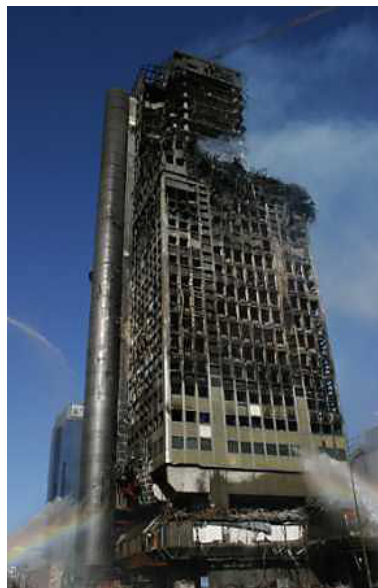
*The Windsor Tower after having burned for almost 24 hours.*

stages over several hours, of floors where the steel support columns and beams had no fire protection. In 2008, the 13-story Delft University Faculty of Architecture Building in the Netherlands, constructed of reinforced concrete, burned for seven hours and experienced a partial collapse of a 13-story section of the building. Yet there remains no documented instance of a steel-framed high-rise building suffering total collapse from fire, and only a small number have experienced partial collapse.

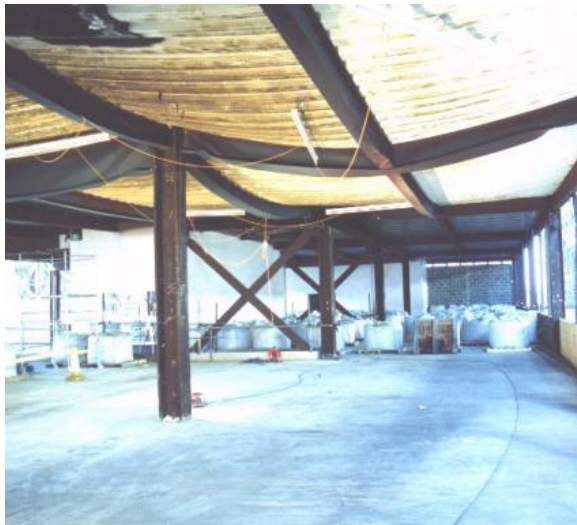
BRE tests in Cardington, United Kingdom.

The NIST survey also noted two major fire test programs conducted at the Building Research Establishment (BRE) Laboratories in Cardington, United Kingdom. The first series of tests, conducted on a representative eight-story composite steel-framed office building, resulted in significant fire damage but did not result in collapse, even with unprotected steel floors. The second series of tests conducted on a seven-story concrete building also did not result in collapse.

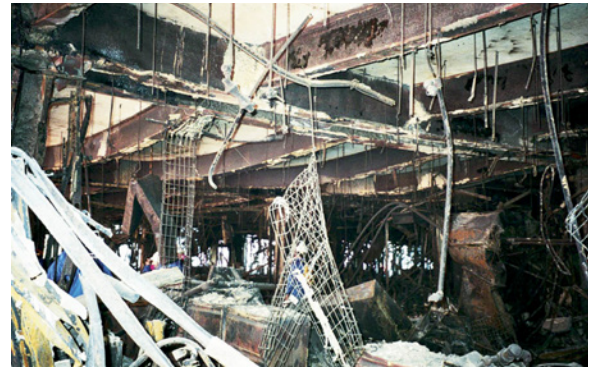
Fire damage in WTC 5 (2002 NIST survey of fires that resulted in total or partial collapse).

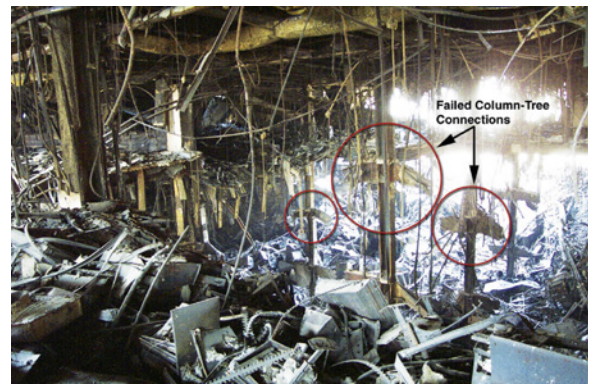
Partial connection and floor failures in WTC 5 (2002 NIST survey of fires that resulted in total or partial collapse).

- **One New York Plaza** experienced local connection failures resulting in filler beams dropping onto their supporting girders on two floors.
- **Alexis Nihon Plaza** experienced a partial collapse of its 11<sup>th</sup> floor, which was arrested by the floor below it.
- **WTC 5** experienced partial collapses of four floors and two bays.

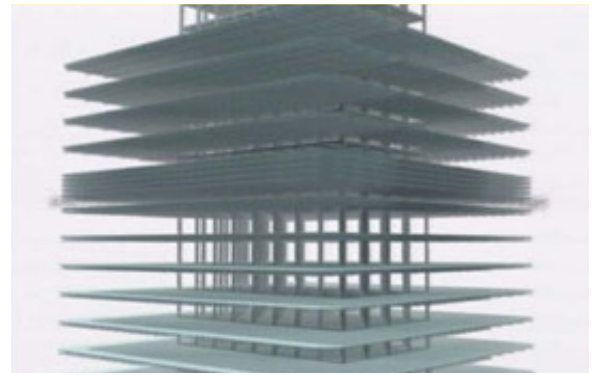
*This PBS NOVA animation attempts to illustrate the “pancake theory.”*

FEMA's scenario for WTC 1 and WTC 2 — which reflected common thinking at that time but was later ruled out by NIST — is what became known as the “pancake theory.” According to this hypothesis, the fires caused the floor trusses to lose their rigidity and sag. As a result of the sagging, the column-to-truss connections failed and the floors collapsed onto the floors below them. This precipitated “an immediate progressive series of floor failures,”

which left behind “tall freestanding portions of the exterior wall and possibly central core columns.” FEMA then stated, “As the unsupported height of these freestanding exterior wall elements increased, they buckled at the bolted column splice connections, and also collapsed. Perimeter walls of the building seem to have peeled off and fallen directly away from the building face, while portions of the core fell in a somewhat random manner.” FEMA also claimed that the upper sections of the buildings then acted as pile drivers, causing “a wide range of failures in the floors directly at and below the aircraft impact zone,” which progressed all the

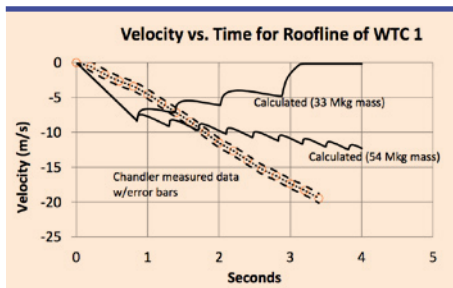
In this graph from Szamboti and Johns' Discussion paper, the observed velocity of the roofline of WTC 1 is compared with the velocity calculated using Bazant and Le's analytical method, but with corrected input values, showing significant decelerations at each floor.<sup>11</sup>

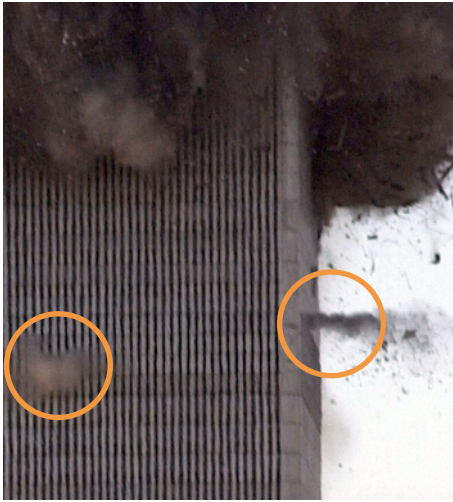
High-velocity bursts of debris, or “squibs,” being ejected from point-like sources in WTC 1 and WTC 2, as many as 20 to 30 stories below the collapse front.

- The floors were not the kind of tightly sealed, highly pressurized containers that would be required to generate overpressures strong enough to burst windows.
- The falling mass would need to act as a flat plate exerting uniform pressure at all points. But the falling upper sections, themselves disintegrating as observed in the videos,

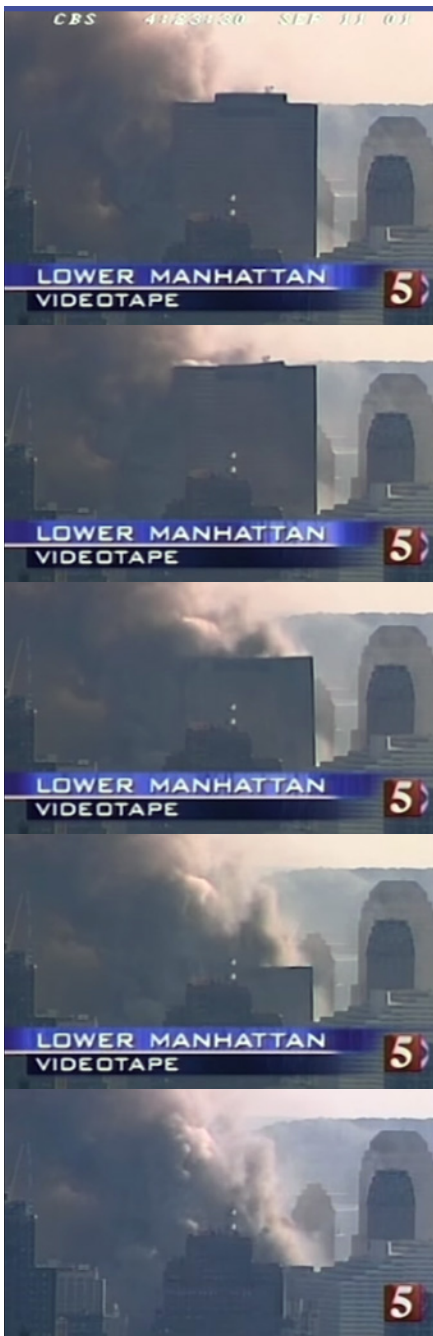
WTC 7 is shown falling symmetrically into its own footprint. It accelerated at free fall for 2.25 seconds of its descent.

Today, NIST acknowledges that WTC 7 fell at a rate of free fall (or the rate of gravity) for a period of approximately 2.25 seconds before it started to

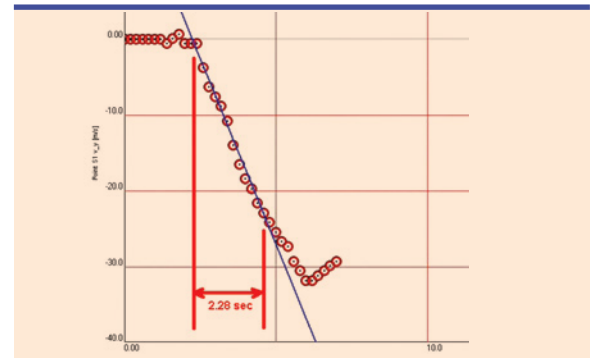
David Chandler's graph from Part 3 of NIST Finally Admits Free Fall plots the velocity of WTC 7's roofline versus time. The slope shows a free-fall rate of acceleration. The sudden change in slope shows the sudden onset of free fall.

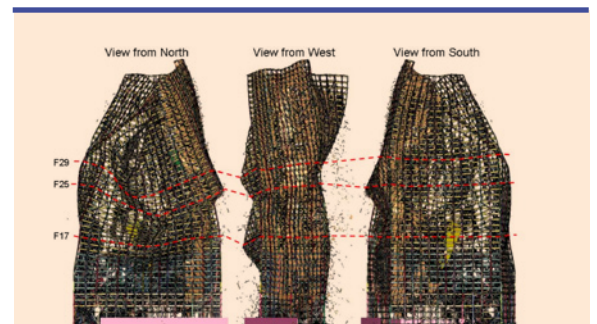
NIST's model of WTC 7's collapse shows large deformations to the exterior of WTC 7 not observed in the videos, while failing to show 2.25 seconds of free fall.

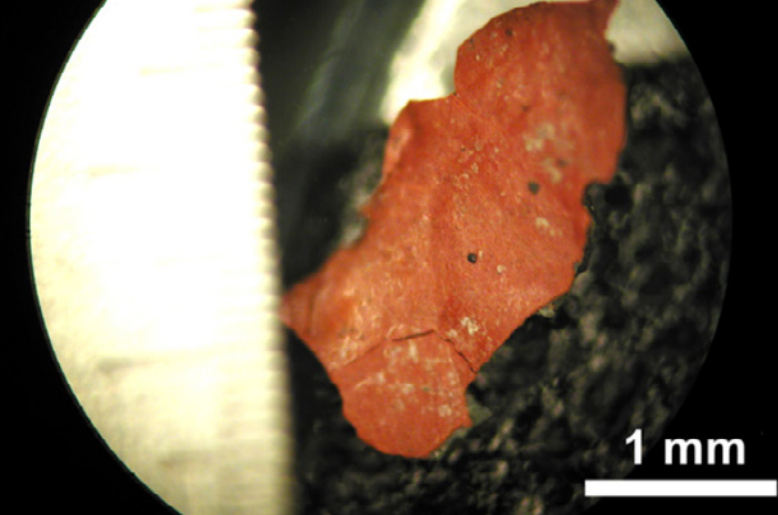
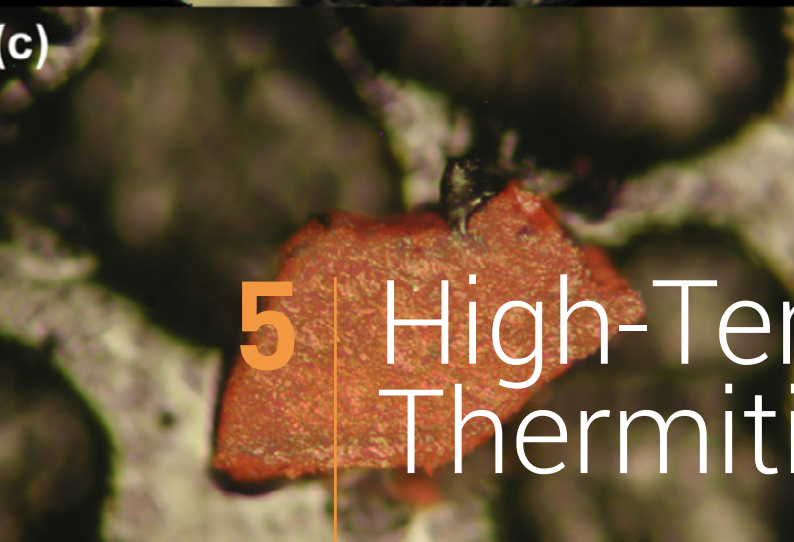
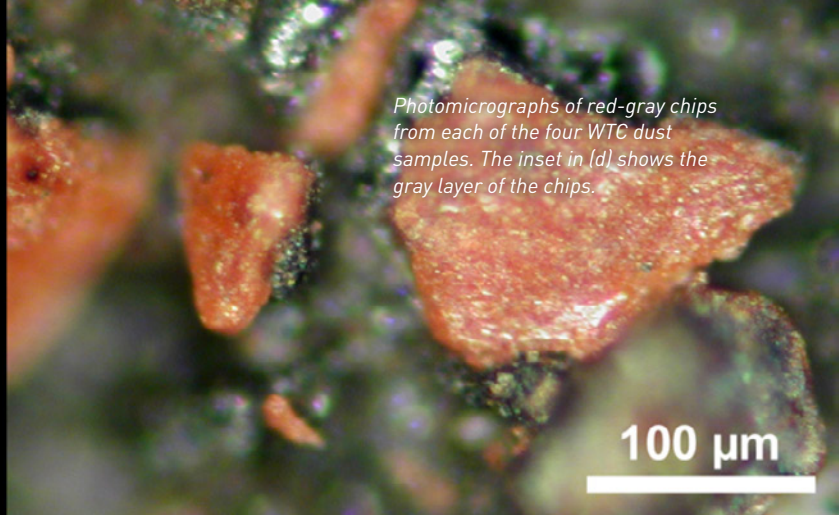
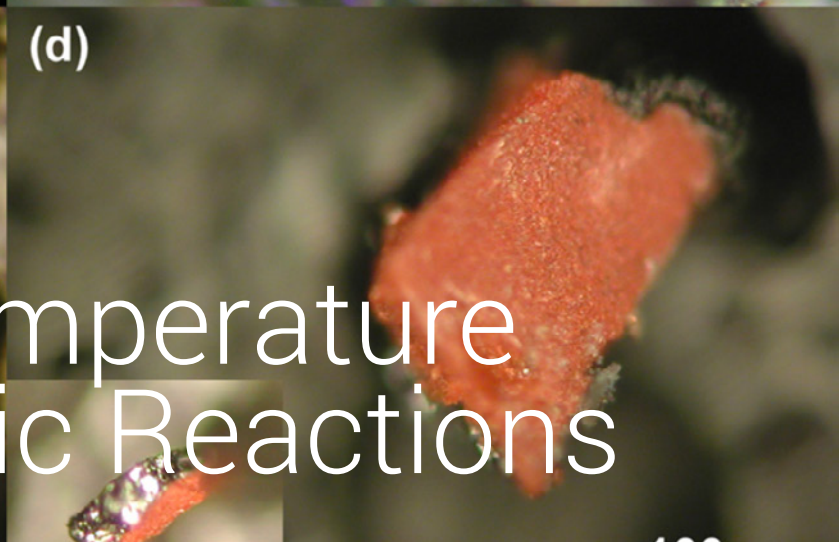
Photomicrographs of red-gray chips from each of the four WTC dust samples. The inset in [d] shows the gray layer of the chips.

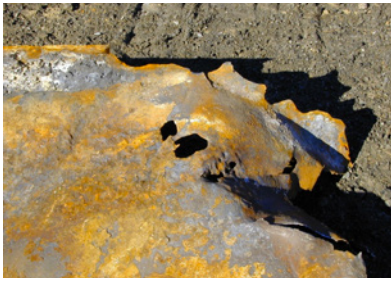
The eroded, sulfidated steel from WTC 7 at the scrapyards before it was cut off and taken for testing.
